# **STRUCTURAL EVALUATION REPORT PHASE II**

**SUFFOLK CITY HALL  
SUFFOLK, VIRGINIA**

**WTS PROJECT NO. 0706-F**

**FINAL ROUGH DRAFT  
30 APRIL 2010**

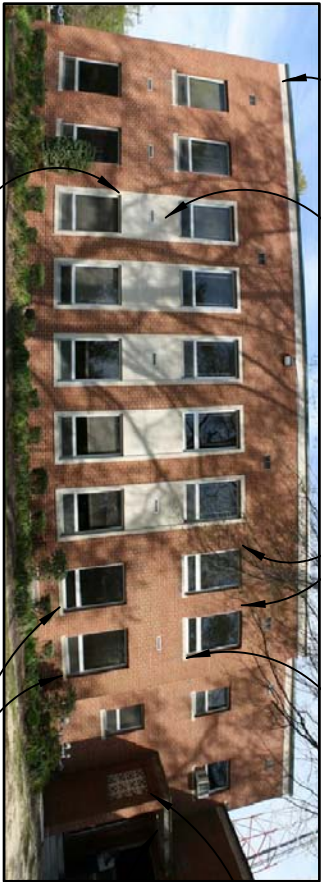
**A**  
A-201  
NTS  
CITY HALL BUILDING - WEST ELEVATION

NEARLY 100% OF STEEL UNTELS ARE SEVERLY CORRODED. SOME UNTELS ARE BOWING AND IN FAILURE. CORRODED STEEL HAS CAUSED MORTAR JOINTS TO POP OUT UNTIL BEARING LOCATIONS, TYPICAL THIS ENTIRE ELEVATION.

CRACK IN LIMESTONE WINDOW SILL.

UNTEL OVER LIMESTONE SOLAR SCREENS IS CORRODED, CAUSING EXTENSIVE DAMAGE AND CRACKING TO LIMESTONE ELEMENTS.

CONCRETE CEILING SLAB AT ENTRANCE CANOPIES IS SPALLING, TYPICAL MOST LOCATIONS.

LADDER CRACKS IN BRICK VENEER.

SPALLED LIMESTONE FACING PANEL.

PLANTERS ARE SEPARATING FROM BUILDING AND EXHIBITING MOISTURE DAMAGE ON STONE.

LIMESTONE VERTICALS ARE CRACKED DUE TO UNTEL DAMAGE.

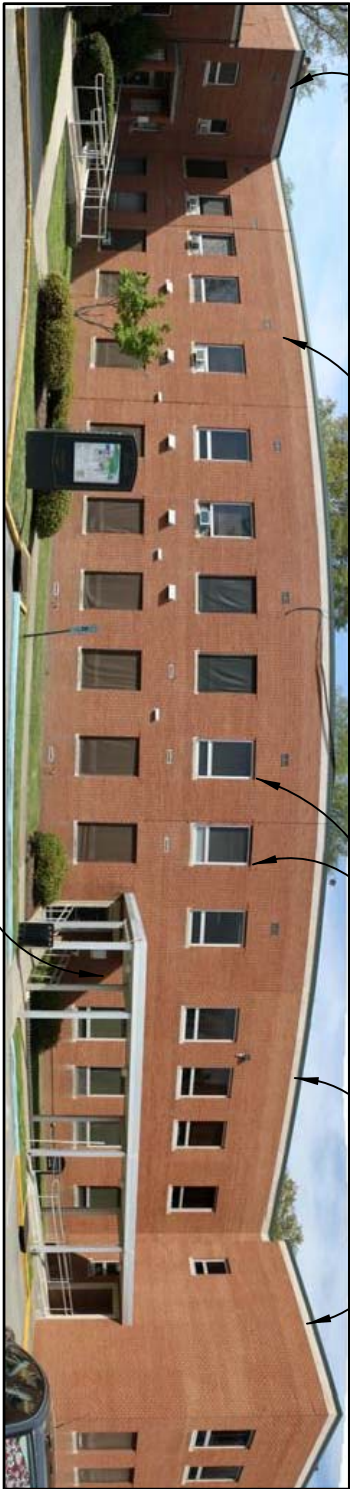
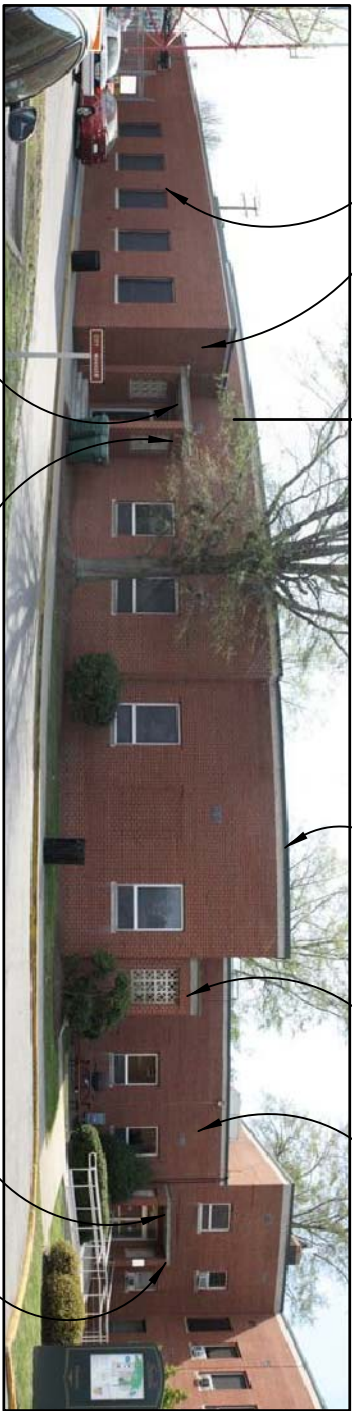
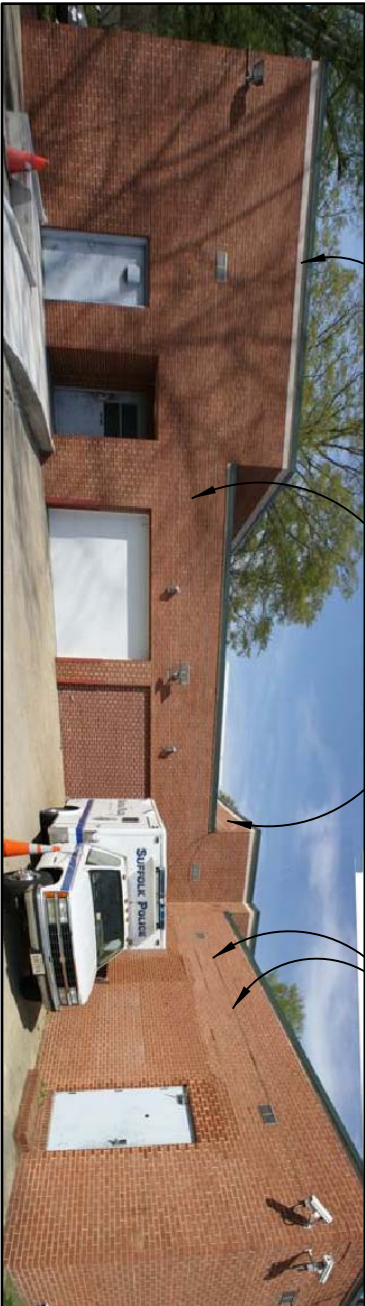
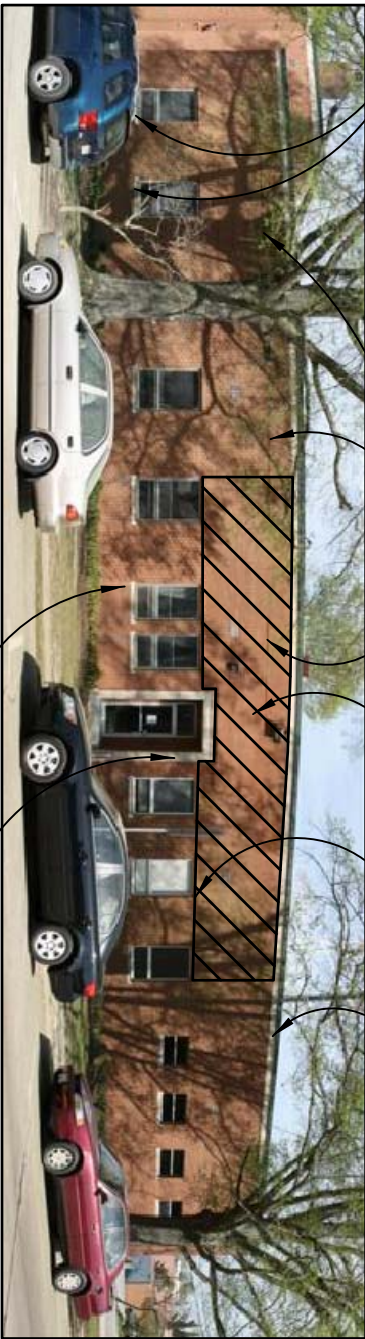
1. NEARLY 100% OF STEEL UNTELS ARE SEVERLY CORRODED. SOME UNTELS ARE BOWING AND IN FAILURE. CORRODED STEEL HAS CAUSE MORTAR JOINTS TO POP OUT UNTIL BEARING LOCATIONS. TYPICAL THIS ENTIRE ELEVATION.

7. CRACK IN LIMESTONE WINDOW SILL.
8. UNTIL OVER LIMESTONE SOLAR SCREENS IS CORRODED, CAUSING DAMAGE AND CRACKING TO LIMESTONE ELEMENTS AND BRICK.
9. CONCRETE CEILING SLAB AT ENTRANCE CANOPIES IS SPALLING, TYPICAL MOST LOCATIONS.

10. LADDER CRACKS IN BRICK VENEER.
11. COMM ADDITION IS IN GOOD CONDITION, BRICK VENEER, WINDOW SILLS AND STEEL UNTELS DO NOT REQUIRE ANY WORK EXCEPT CLEANING OF THE BRICK.

12. HATCHED AREA OF BRICK INDICATES EXTENT OF AREA WHERE BRICK IS TO BE PINNED, AS RECOMMENDED IN THIS REPORT. REFER TO RECOMMENDATION SECTION.

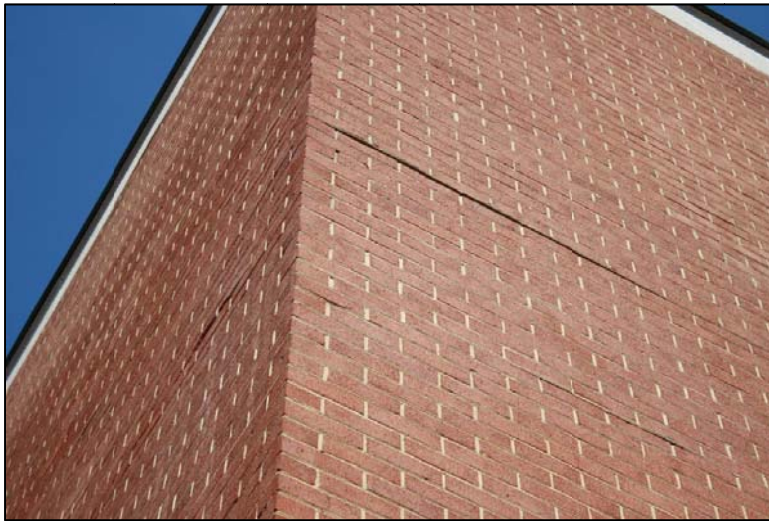
2-6a. Mortar damage at horizontal reinforcing

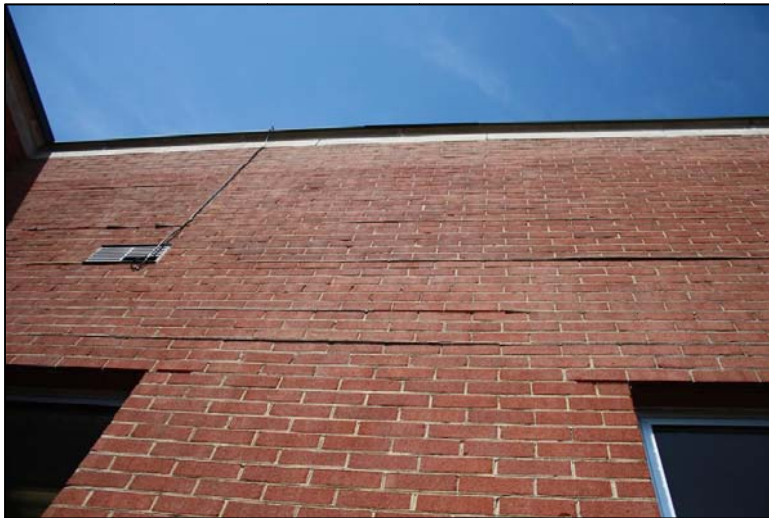
2-6b. Mortar damage at horizontal reinforcing

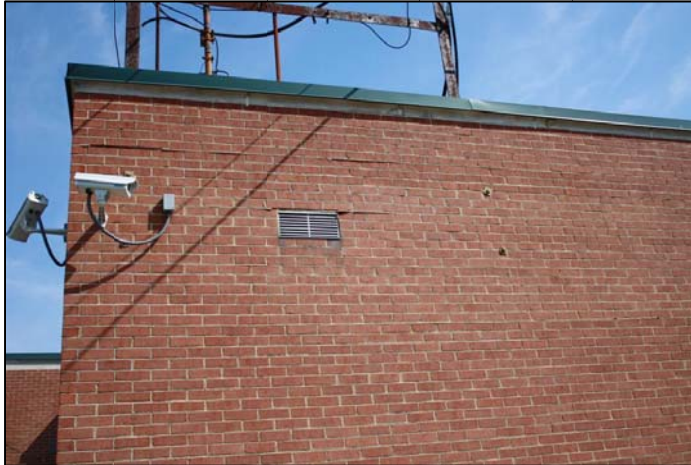
*2-6a. Damaged mortar at grill and horizontal joint reinforcing*

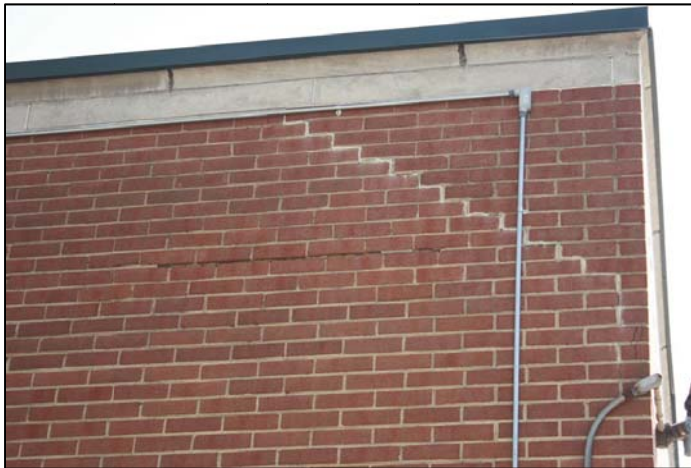
*2-6b. Building corner with ladder cracks*

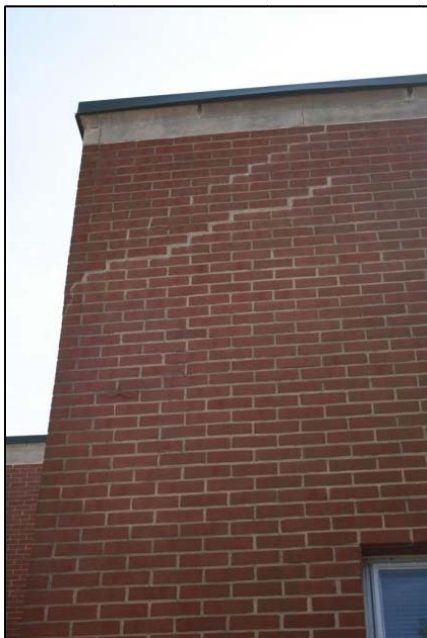
*2-6c. Building corner with ladder cracks*

There are no vertical control joints in the exterior brick veneer. These vertical control joints allow the brick veneer to expand and contract laterally without cracking. Vertical joints are usually located adjacent to window heads and the corners because these areas are the weakest part of the wall where it is most likely to crack.

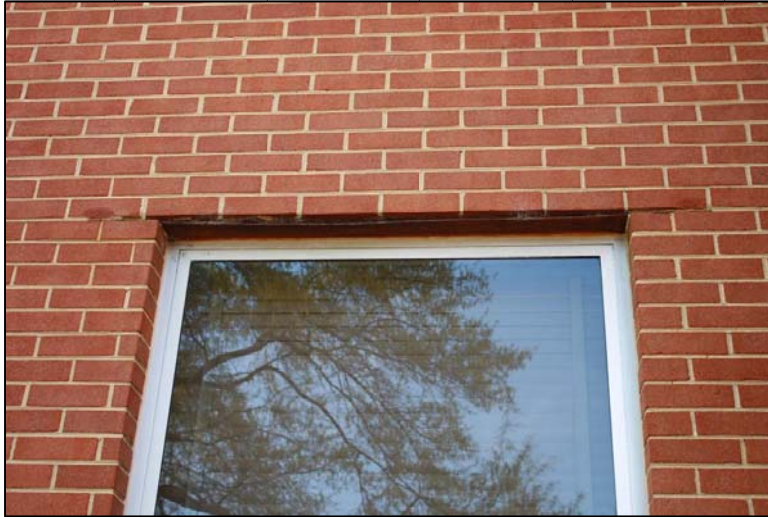
*2-2a. Typical window lintel with no weep holes and corroded steel angle*

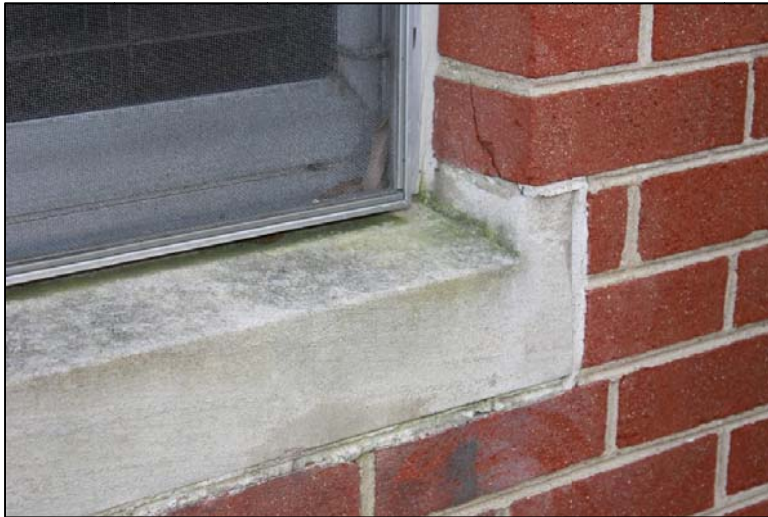
*2-2b. Limestone window sill with spalled edge and cracked brick above*

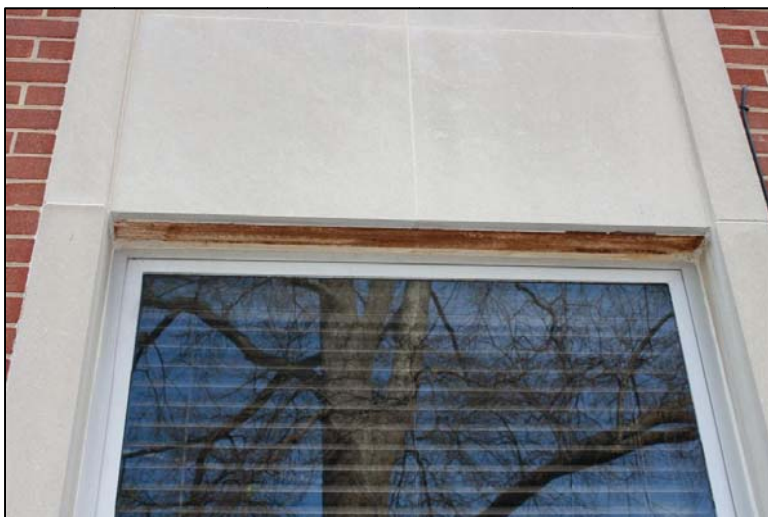
*2-2c. Window lintel with corroding, non-galvanized steel angle*

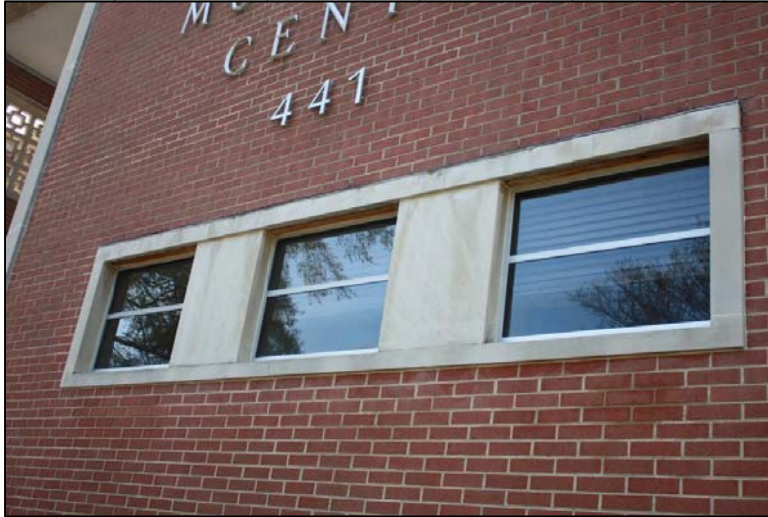
*2-3a. Limestone window trim with some hairline cracks in the lintel and sill*

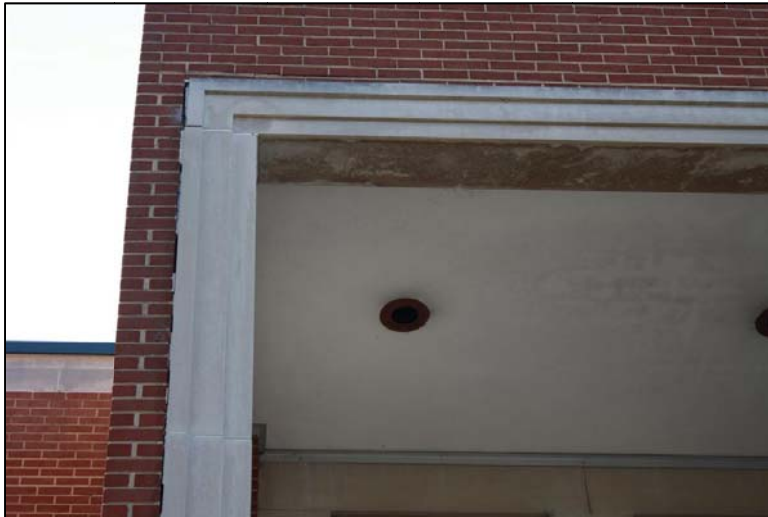
*2-3b. Front entrance limestone surround of City Hall Building*

The limestone surrounds at main entrance of the City Hall Building is exhibiting more separation from the other entrances due to the poor condition of the lintels at this location. This is addressed in more detail in the Building Entrances section of this photo narrative.

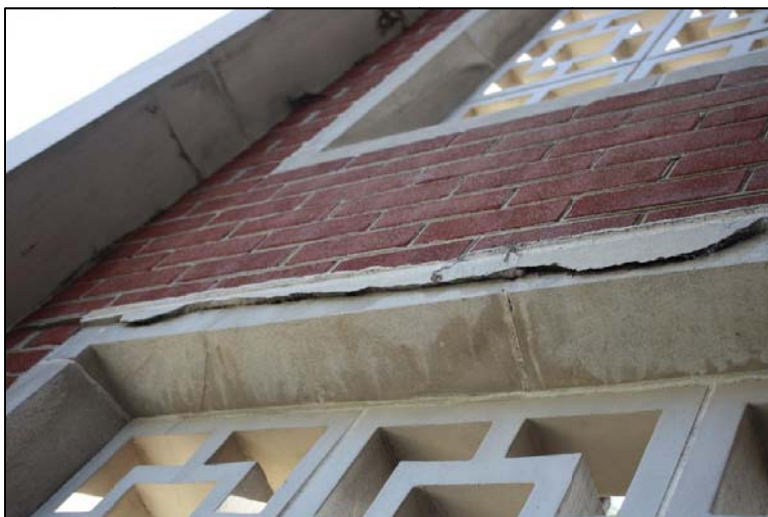
*2-3c. Cracked solar screen lintel*

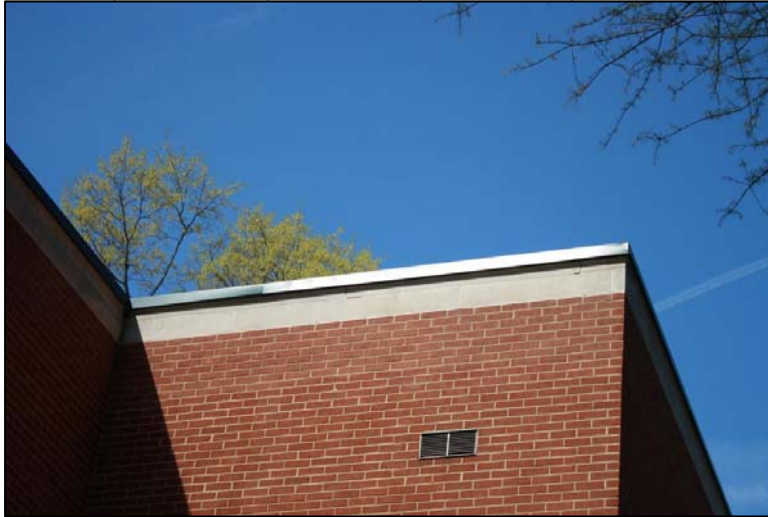
*2-4a. Metal and limestone coping*

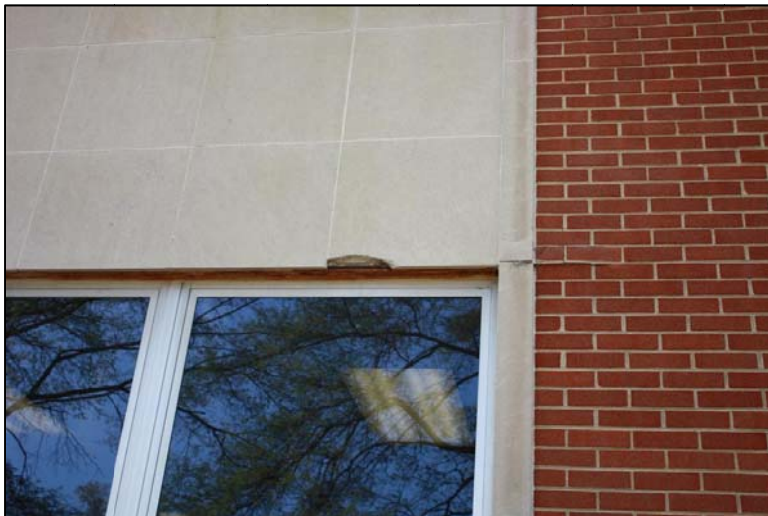
*2-4b. Spalling limestone facing panel and limestone vertical*

In one specific area, the limestone is significantly damaged or is separating from the supporting CMU building structure.

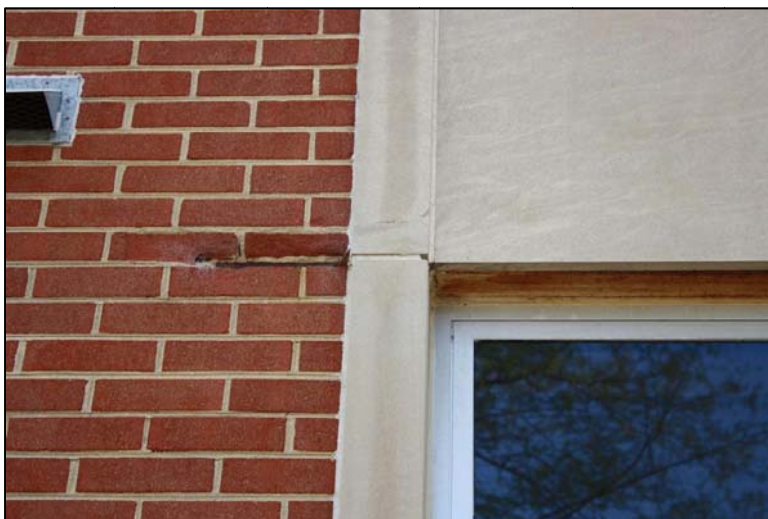
*2-4c. Window lintel with corroding steel angle, damaged brick and limestone*

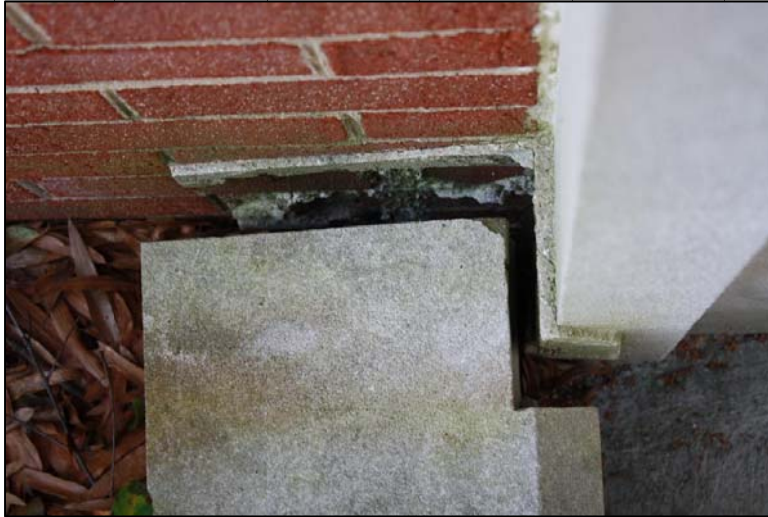
*2-5a. Limestone planter separating from building (northeast entrance)*

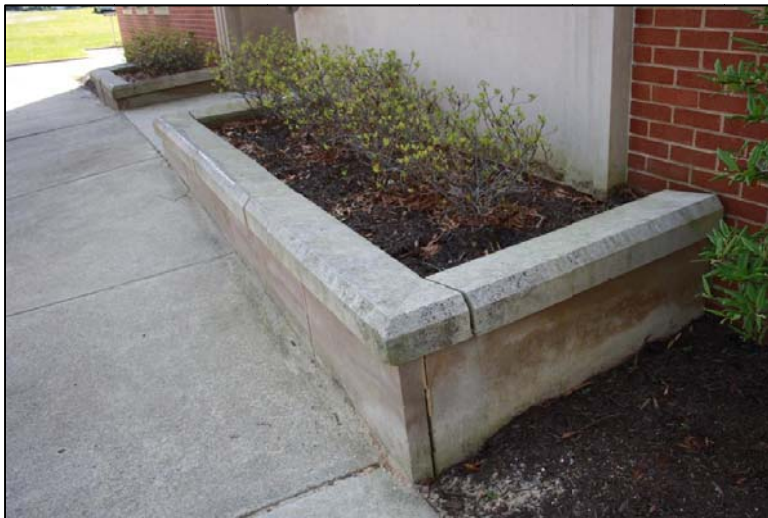
*2-5b. Damaged planter with joints separating (northeast entrance)*

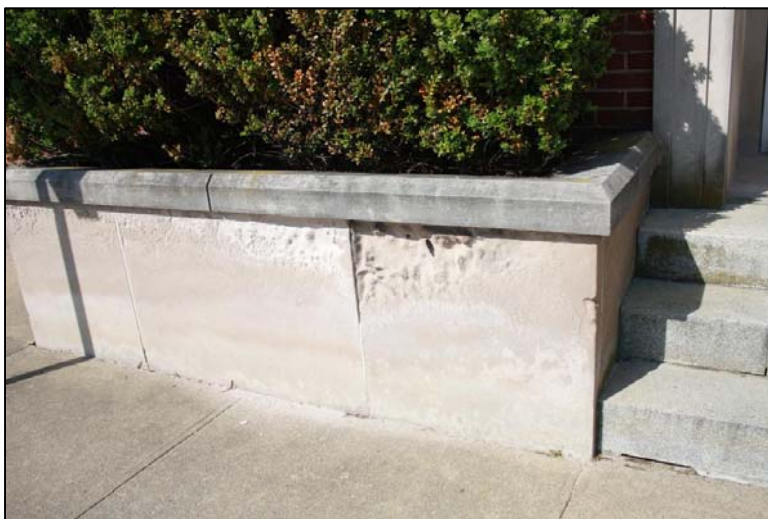
*2-5c. Planter with damaged limestone (east entrance)*

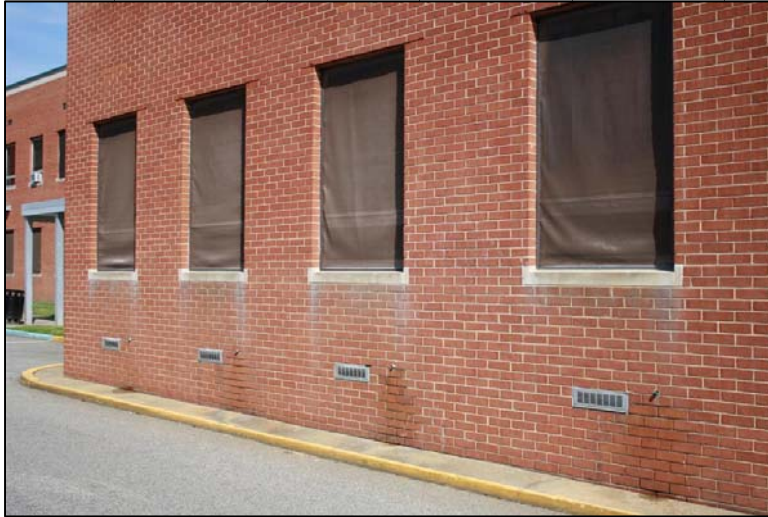
*2-6b. Efflorescence below limestone window sills and staining at condensation drain openings*

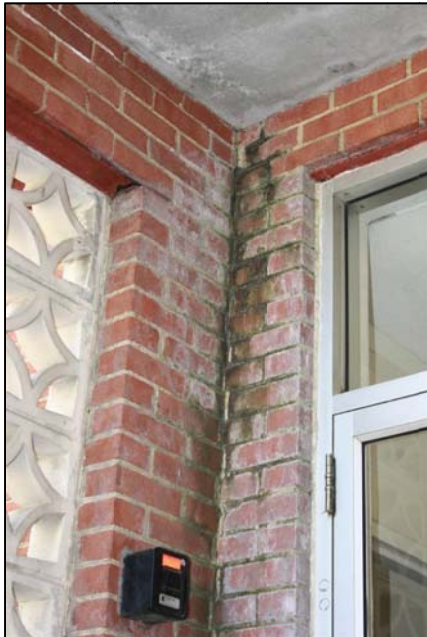
*2-7a. Excessive mold/mildew within entrance way*

The west side of the building has the most extensive and advanced discoloration. The west entrance canopy of the Old Police Building, located adjacent to the City Hall Building, is exhibiting heavy, unsightly mold and mildew.

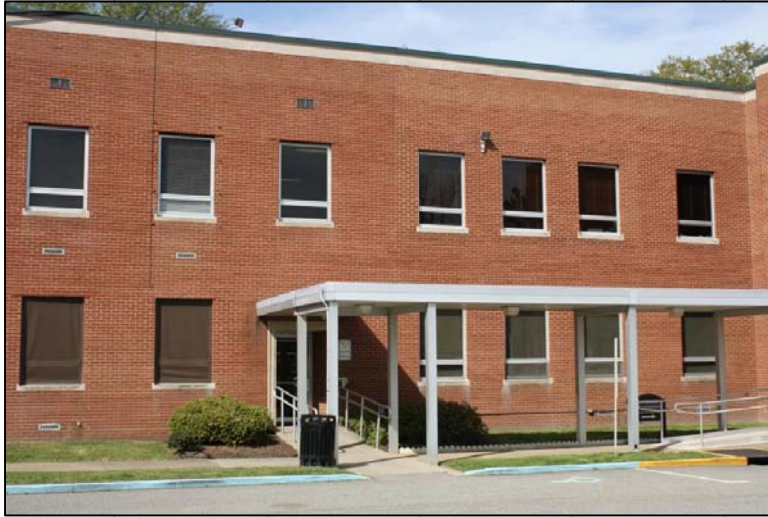
*2-7b. Expansion joint at 2-story addition only extends along 2nd floor plane*

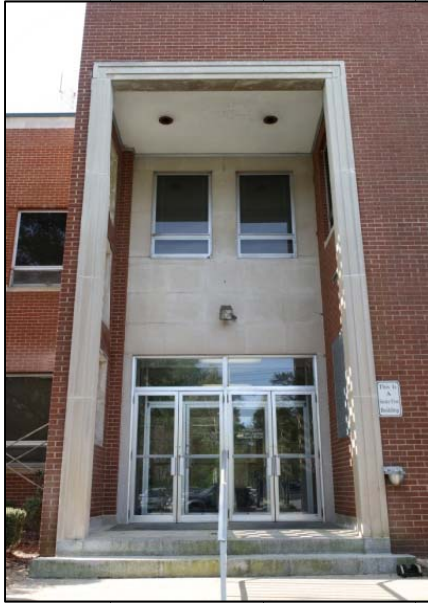
2-6a. Front Entrance of the City Hall Building

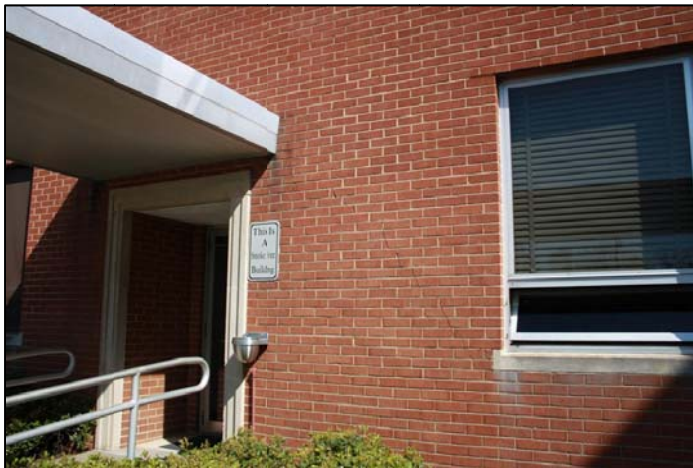
2-6b. Diagonal crack extending between back entrance at stair and window

There is one unusual, diagonal crack at the back entrance adjacent to the stairway. Diagonal cracks normally indicate differential settlement. However, this crack goes from the windowsill and goes up and to the left rather than downward, which would be expected with differential settlement. This crack was most likely caused by the lack of adequate control joints in the brick veneer as opposed to the soil conditions.

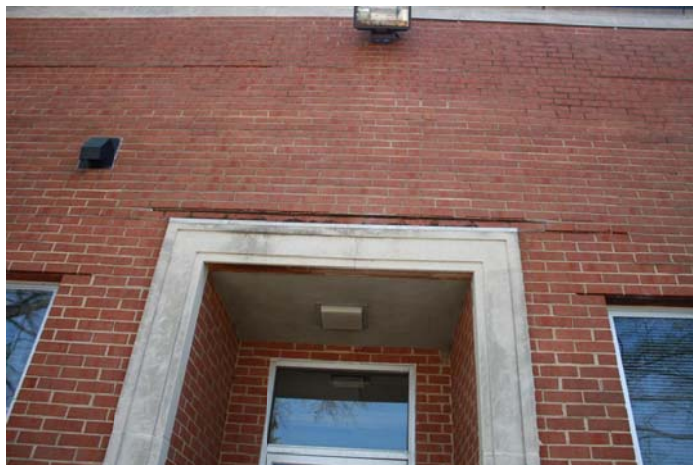
2-6c. Damaged lintel and joints at horizontal masonry reinforcing Wall is bowing along this area.

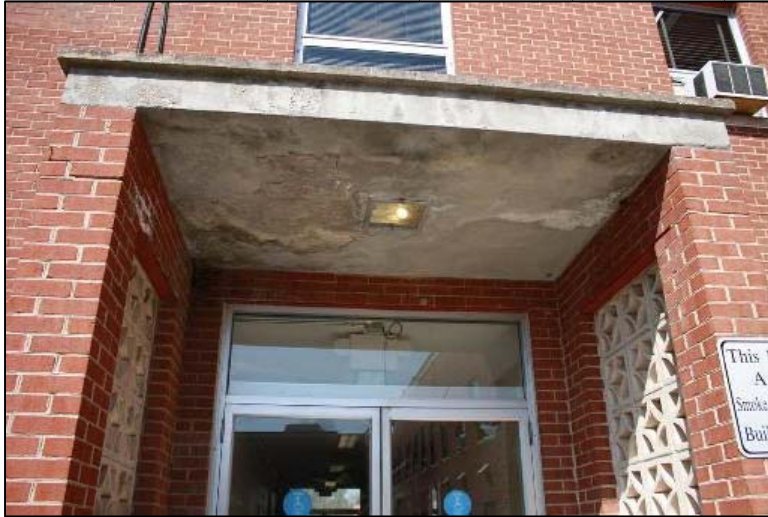
*2-6a. Entrance canopy with damaged joints at solar screen lintels*

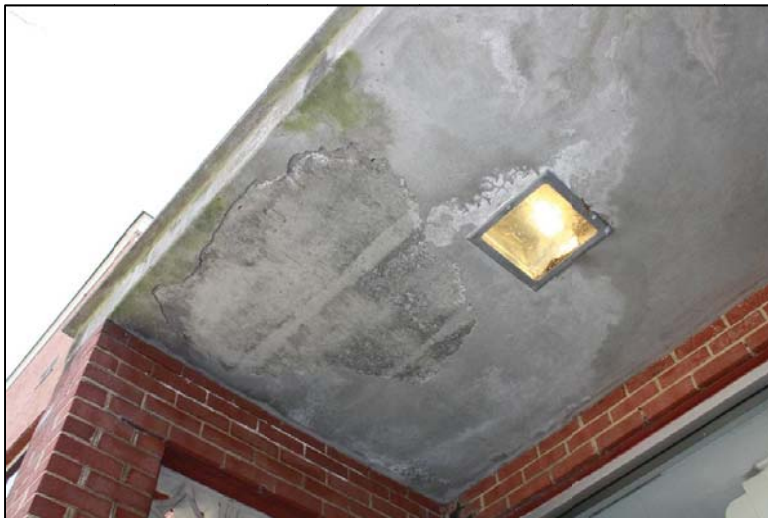
*2-6b. Spalling and discolored concrete ceiling Poor lighting*

The entrance canopies on the Old Police Building are in poor condition overall. The concrete ceilings are spalling and discolored. Most of the deterioration can be attributed to the moisture infiltration problems occurring throughout the rest of the building. The lintels at the sidewall solar screens are significantly cracked and deteriorating. Additionally the lighting levels provided by the cast-in-place fixtures appear to be inadequate and the fixtures themselves are quite unsightly. Additionally there are no handrails at some of the entrances.

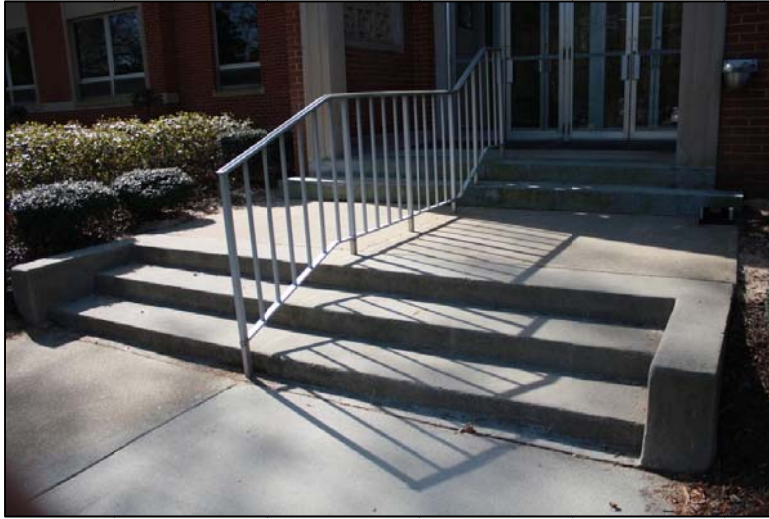
*1. Main Entrance into City Hall Building*

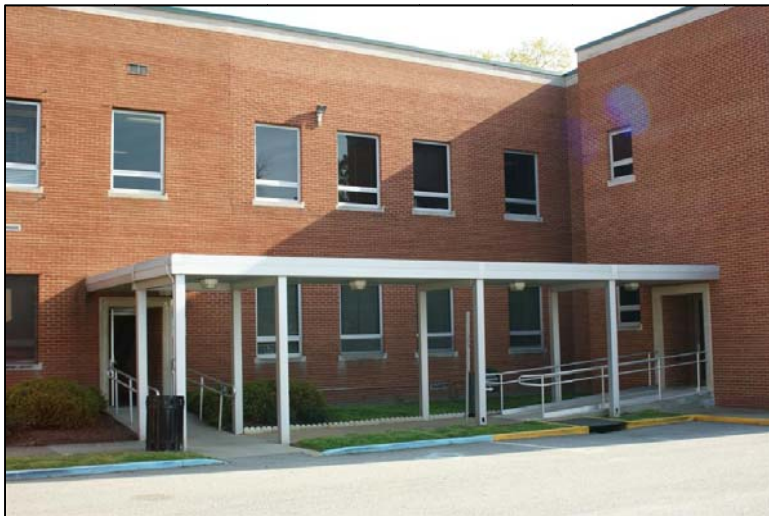
*2. Covered entrance with ramps and automatic door openers, south side of City Hall Building*

A covered, ADA accessible entrance has been added on to the south side of the building.

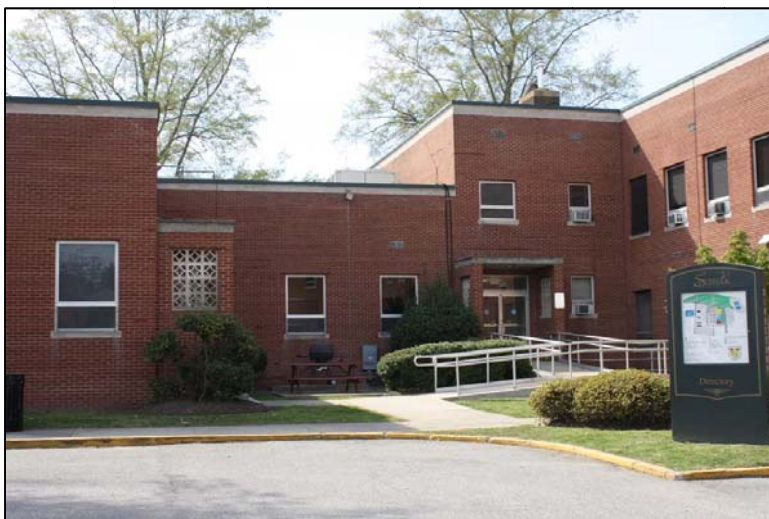
*3. East entrance into Old Police Building with ramp*

There is only one ADA compliant entrance into the Old Police building. A ramp was added on at the east entrance of the building.

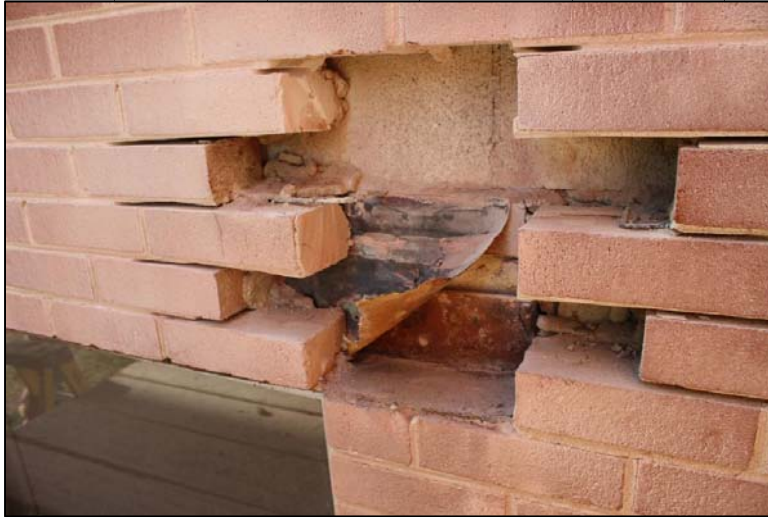
*2-6a. Corner of Window Lintel*

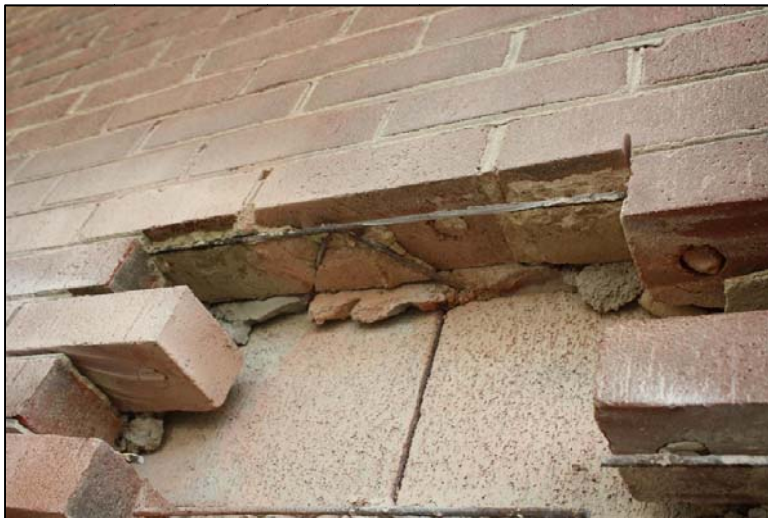
*2-6b. Horizontal Joint Reinforcing*

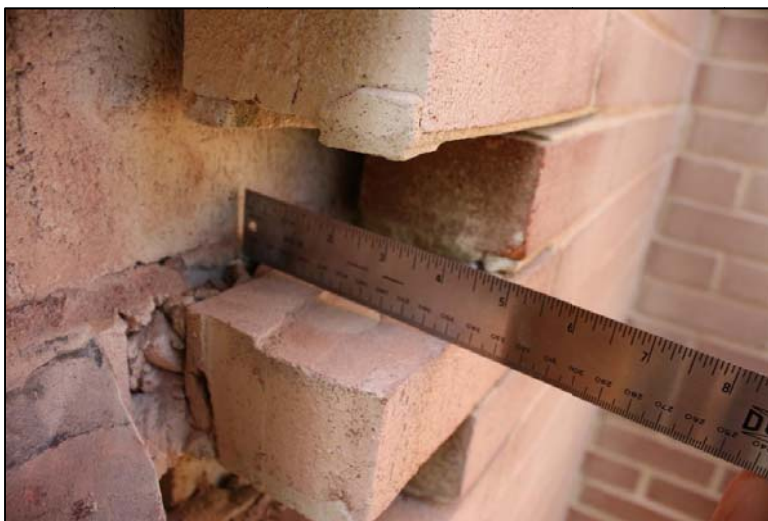
*2-6c. Depth of Brick and Collar Joint*

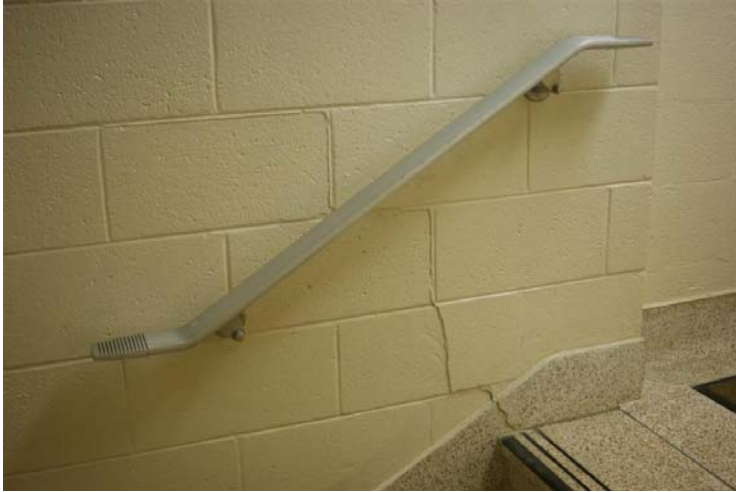
2-2a. Stair at Juncture of City Hall Building and Old Police Building

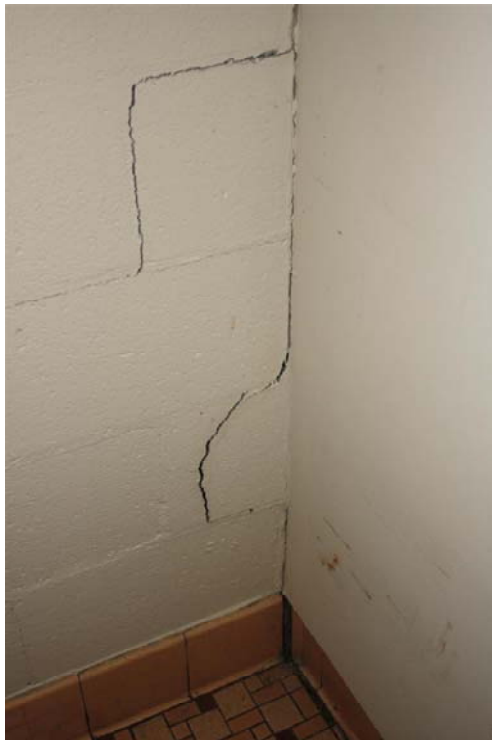
2-2b. Wall corner at bathroom

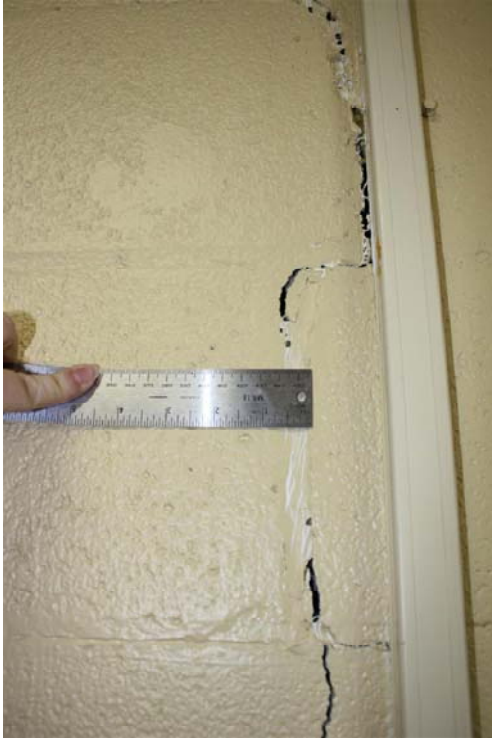
The cracks in the interior CMU partition walls are a result of differential settlement under the slab on grade.

2-2a. Vertical wall crack

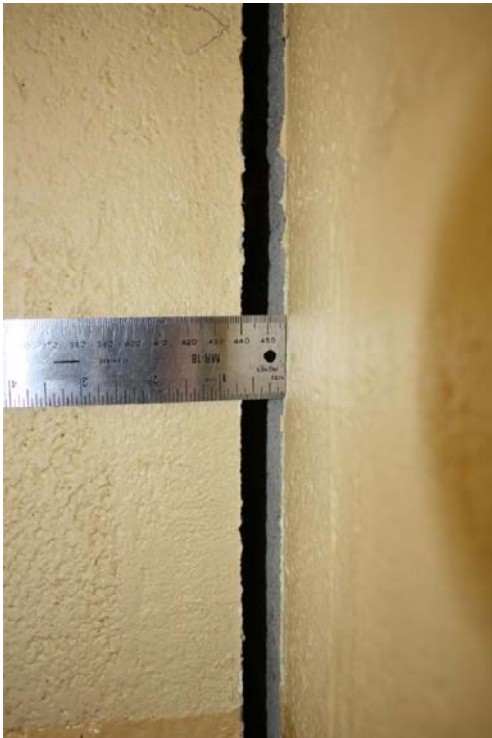
2-2a. Interior CMU partition separating from exterior CMU wall

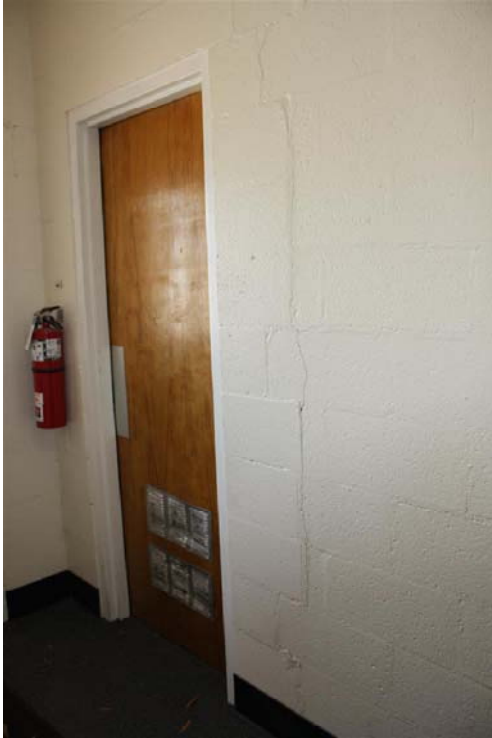
2-2a. Vertical wall crack adjacent to door

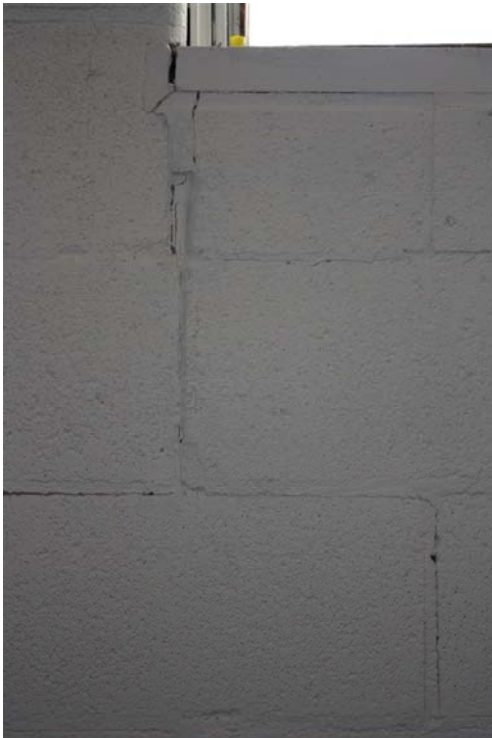
2-2a. Crack occurring below window sill corner

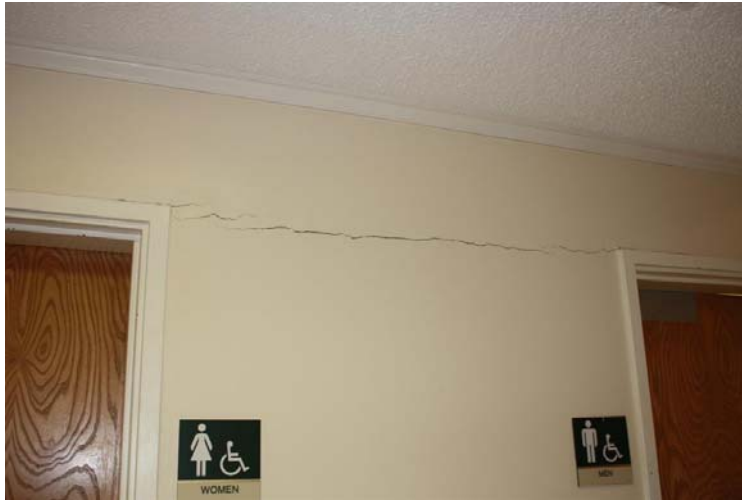
2-2a. Horizontal wall crack between skewed doors.

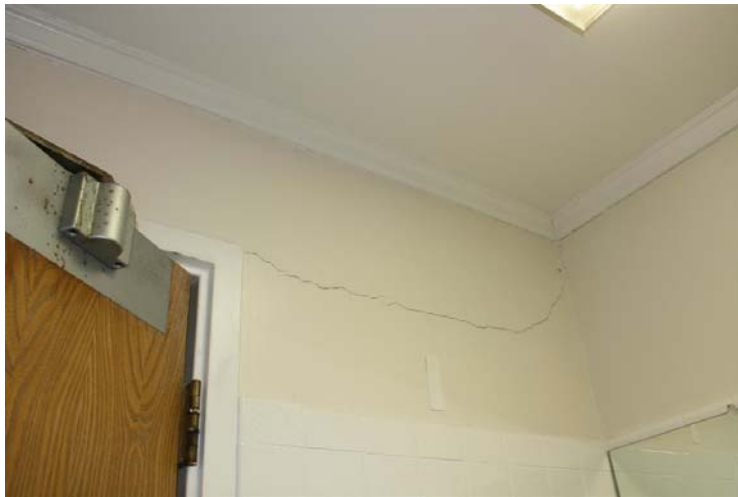
2-2b. Wall crack extending from skewed door to ceiling corner

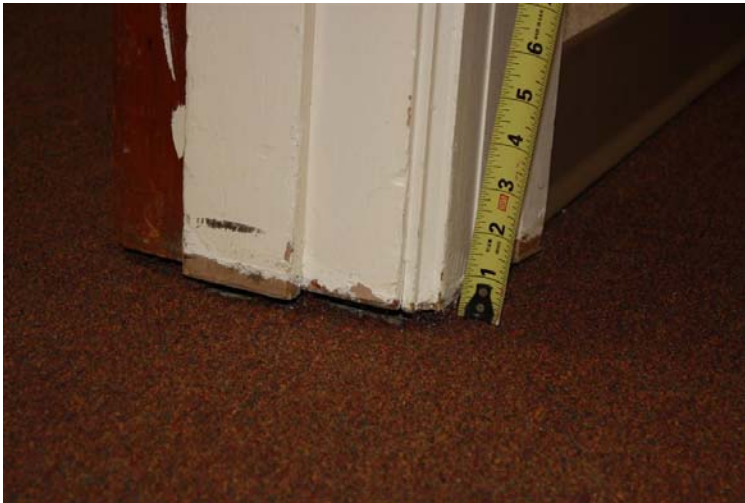
2-3b. A half inch gap between the floor and partition

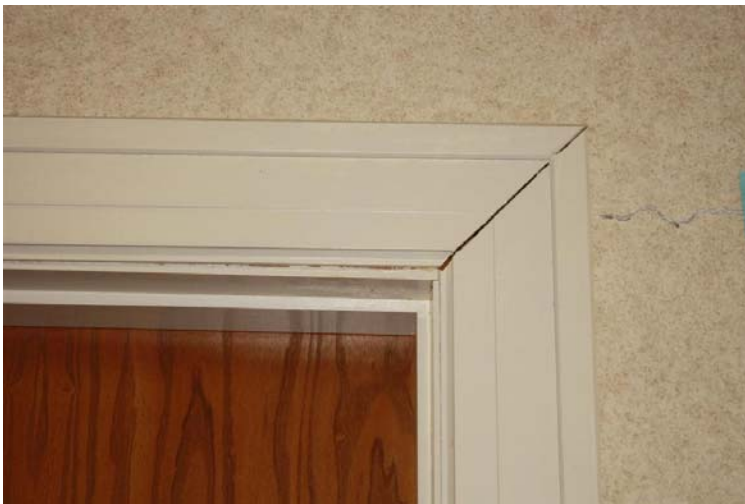
2-3c. Door casing separating at skewed door opening

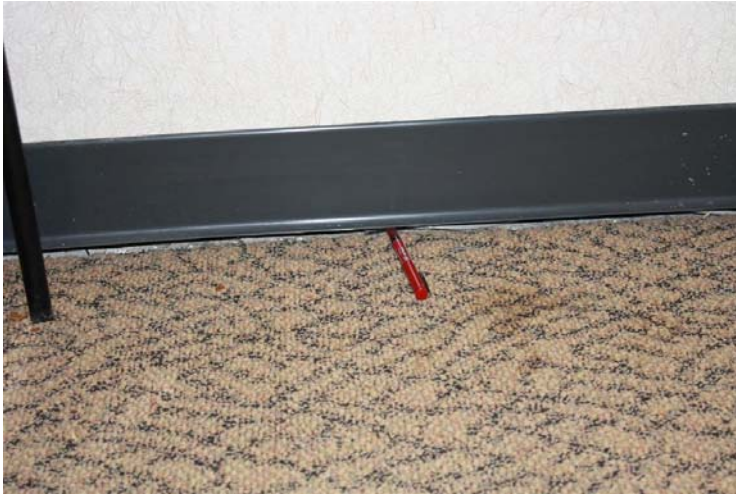
2-3a. Gap occurring between office floor and partition

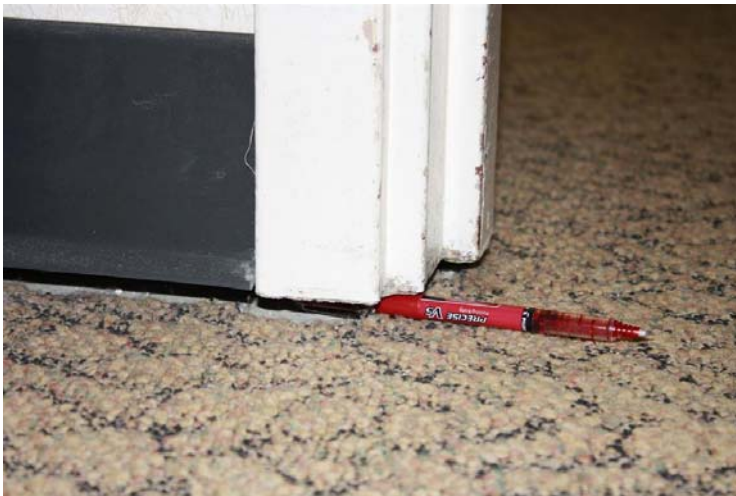
2-3b. A half inch gap between the floor and partition at offices

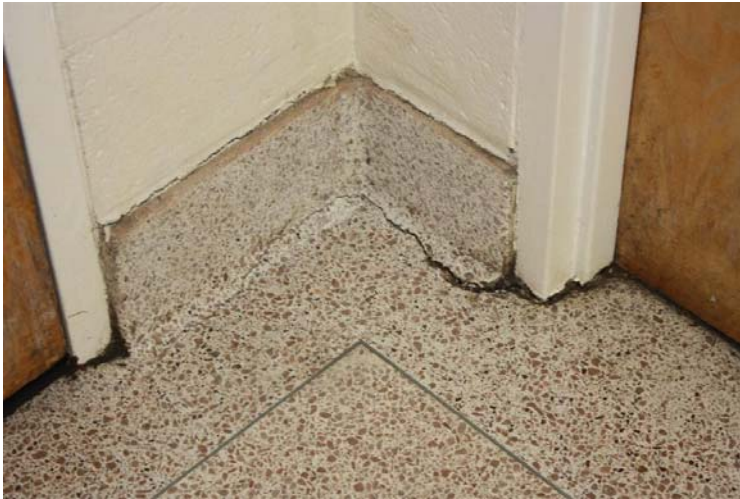
2-2a. Cracked terrazzo base

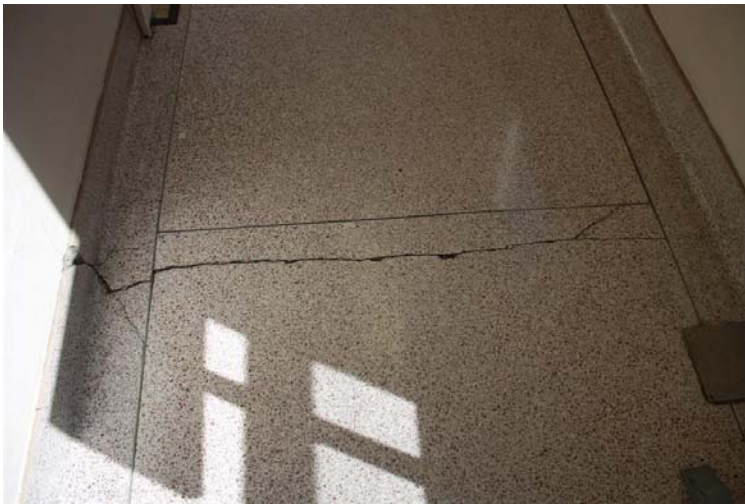
2-2b. Cracked terrazzo floor

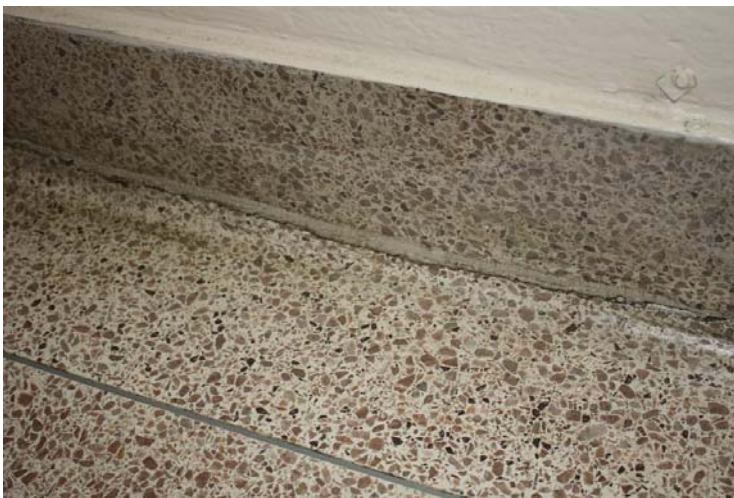
2-2b. Crack occurring between terrazzo base and terrazzo floor

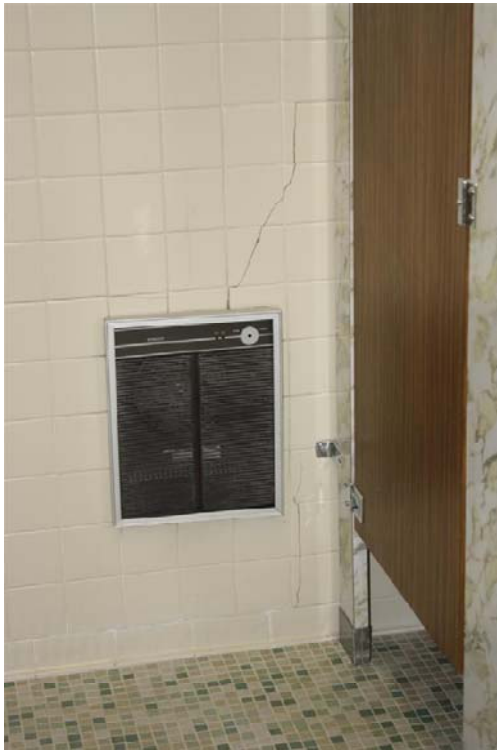
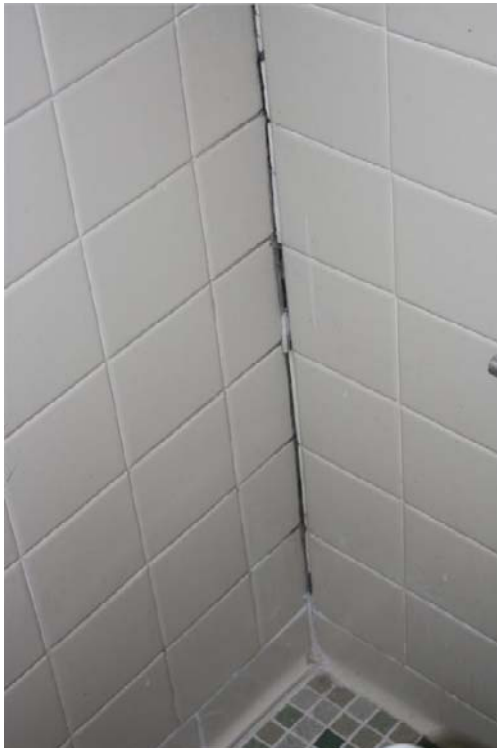
2-3a. Women's Bathroom (southeast corner of City Hall Building)

The women's bathroom at the southeast corner of the City Hall Building has cracked wall tile, possibly caused by shrinkage in the CMU substrate.

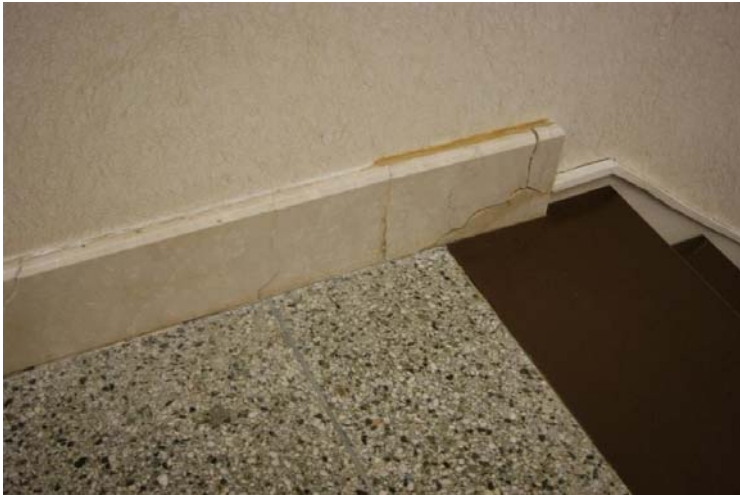
2-2a. Cracked stone base at stair

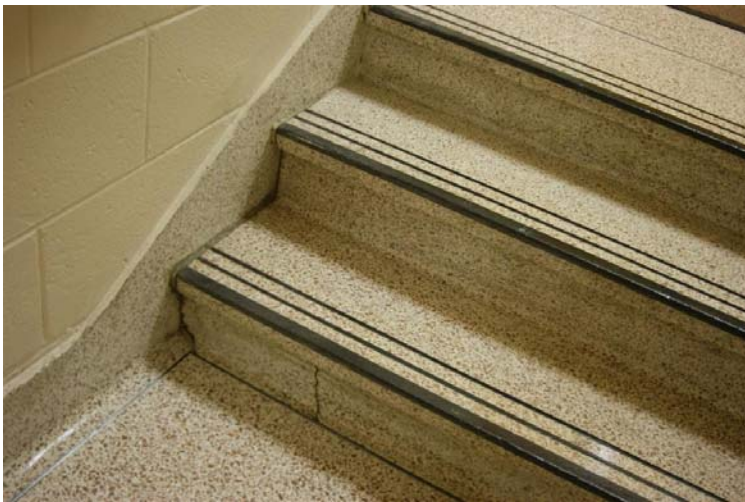
Due to the differential settlement being experienced by the building, several areas of terrazzo flooring, terrazzo base, and terrazzo stairs are exhibiting cracks. In some locations the terrazzo, tile, or stone base is cracking due to differential settlement between the wall and the floor.

2-2b. Cracked terrazzo steps

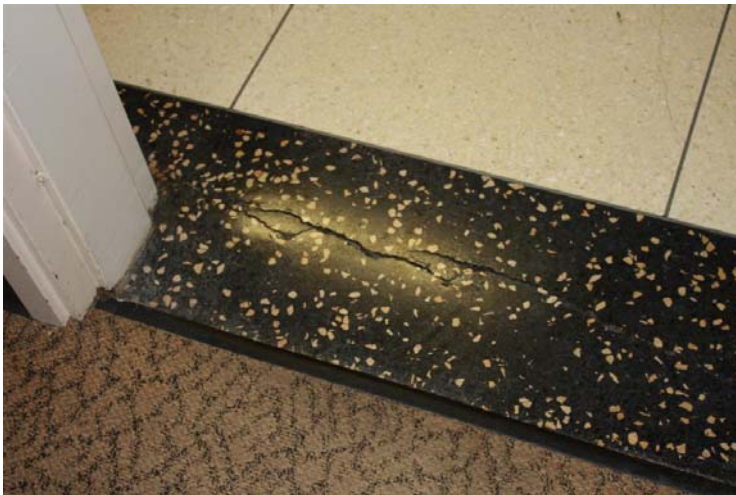
2-2b. Cracked terrazzo at door sill
